Lincoln Cathedral: North West Turret Phase 2 (1 of 3 projects funded)

Lincoln Cathedral: NW Transept and Triforium Roof repairs (2 of 3 projects funded)

Lincoln Cathedral: Lead Pinnacles Repairs (3 of 3 projects funded)

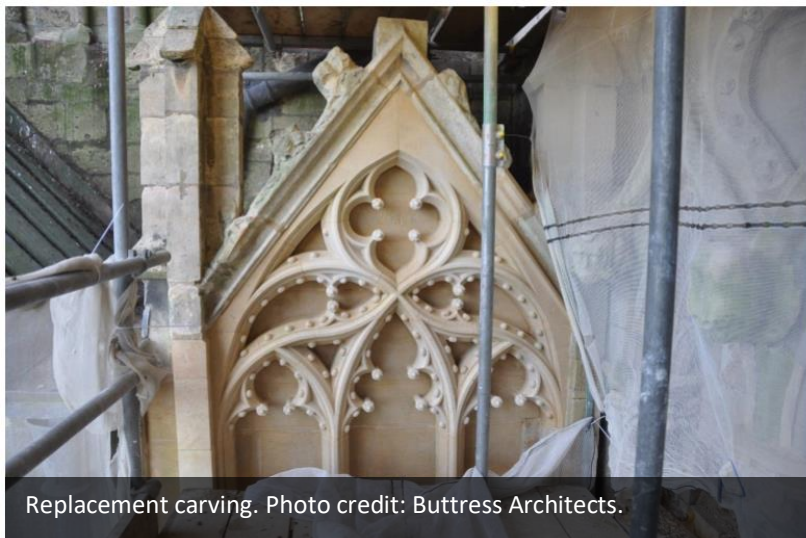
Replacement carving. Photo credit: Buttress Architects.

All of the works, other than scaffolding, were carried out by the cathedral's in-house works department and were completed in March 2016. The works involved cleaning and recording masonry and assessing individual stones, masonry repairs, replacing stones including ashlar blocks, mouldings, corbel stones, copings, finials and carved capitals. Other works included the renewal of the 14th-century pinnacle, which was re-fixed with a stainless-steel dowel rod.

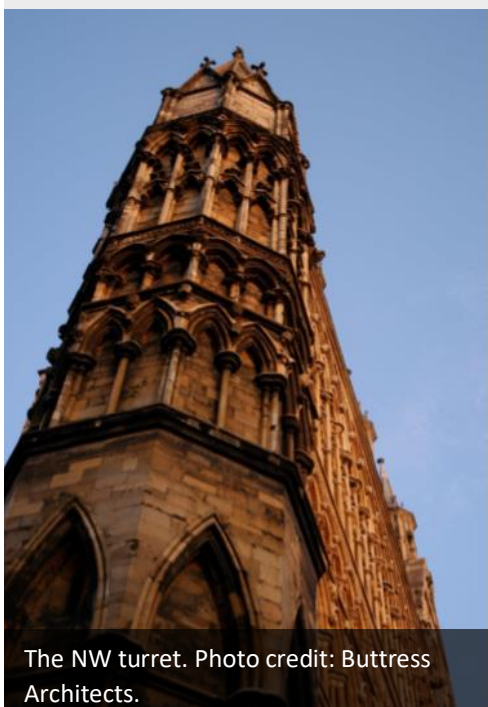
The NW turret. Photo credit: Buttress Architects.

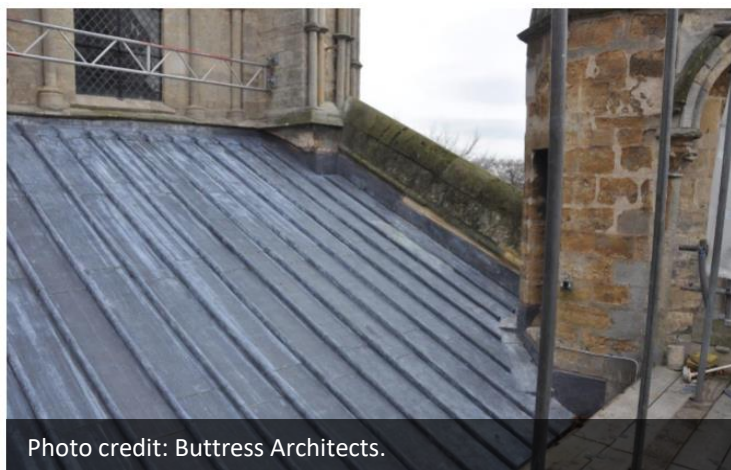
Photo credit: Buttress Architects.

Lincoln Cathedral completed all work within the stated timescale. This first grant involved lead stripping and recasting, construction of new parapet gutters, reboarding, and roofing repairs to cover St Hugh's Choir and the transepts. The second round included masonry repairs, stones and carvings being replaced, removal of damaging and over-hard mortar; and repointing.

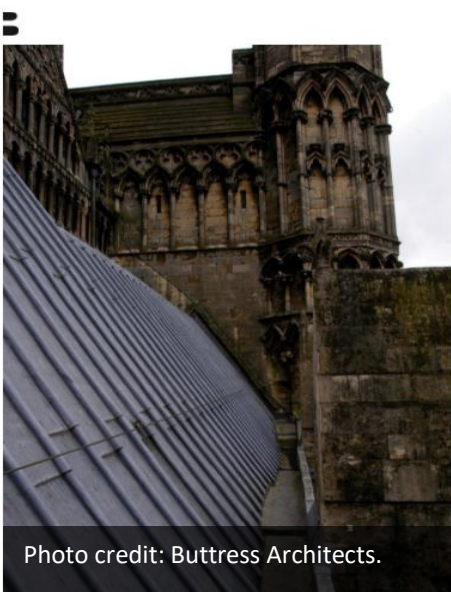
Photo credit: Buttress Architects.

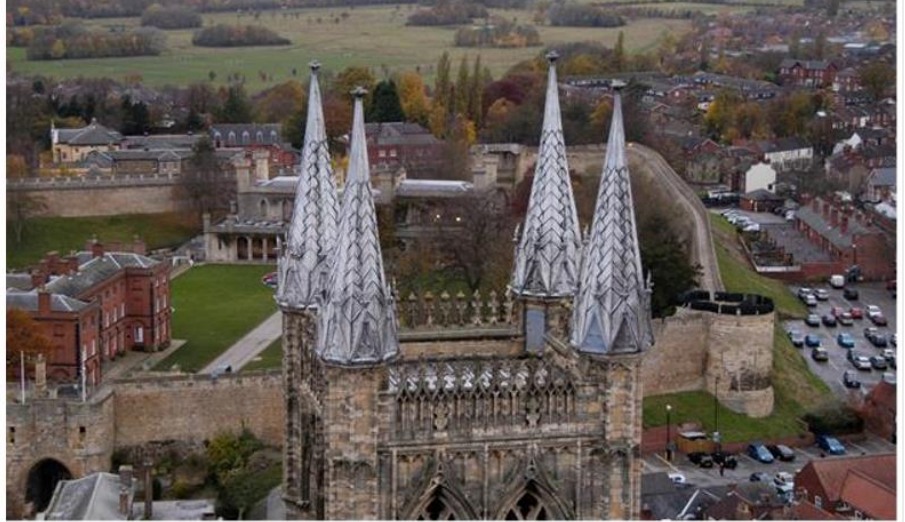
Four of the twelve pinnacles. Photo credit: Buttress Architects.

Lincoln Cathedral completed all work within the stated timescale. The works, carried out by specialist conservation abseilers, included joinery repairs to the twelve timber pinnacles on the three Cathedral towers, re-fixing of lead, and some minor elements of masonry repair. Doors were repaired to give access into each pinnacle and ventilation introduced to allow for air movement within the structure.

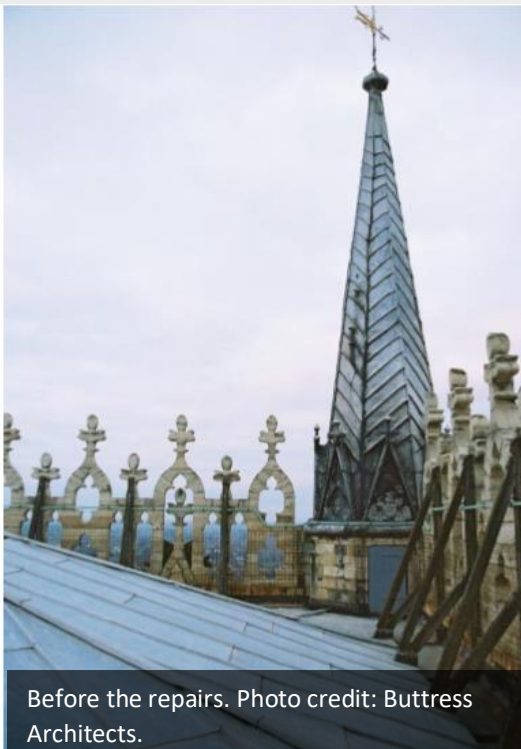
Long-standing problems with the twelve timber pinnacles on the three cathedral towers, identified over 20 years ago, had become acute, with instances of lead sheet covering slipping and falling off. The pinnacles are substantial timber-framed structures clad in lead, each the size and complexity of a small spire. They are very visible as part of the Lincoln skyline and there were public safety concerns over loose lead sheets potentially falling to the ground.

Before the repairs. Photo credit: Buttress Architects.
