CASE STUDY ELECTRIC HEATING SYSTEM

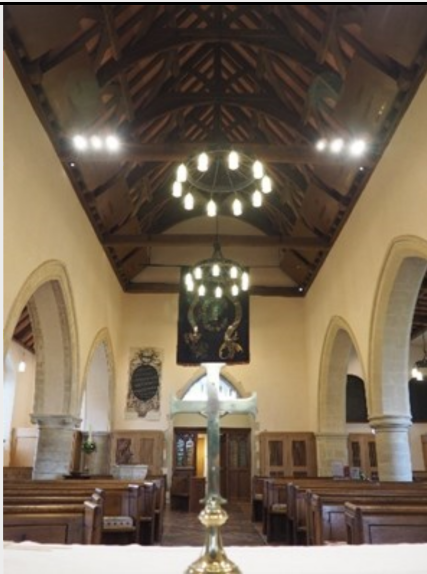
1 The brown rectangles on the nave ceiling are electric far-infra-red radiant panel heaters. They warm the church through a combination of radiant and convective heating. The brown powder-coating was chosen to match the ceiling trusses.

- 16 x 3kW far-infra-red heating panels on the nave ceiling, on metal fixing brackets, powder-coated in brown to match the ceiling trusses.
- 14 x 2kW far-infra-red heating panels on the aisle ceilings, powder-coated in off-white to match the wall plaster.
- 6 x 2kW under-pew electric heaters.
- 3 heating zones: nave, north aisle and south aisle, plus timers for the chancel heaters.

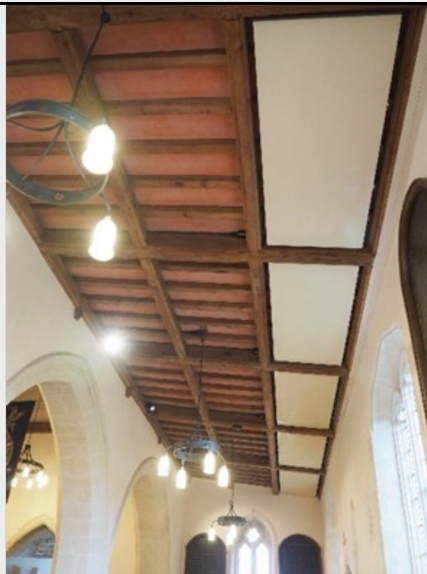
2 The radiant panels on the north and south aisle ceilings are powder-coated off-white to match the walls. They are controlled by a separate set of controls to the nave, allowing the areas to be heated separately.

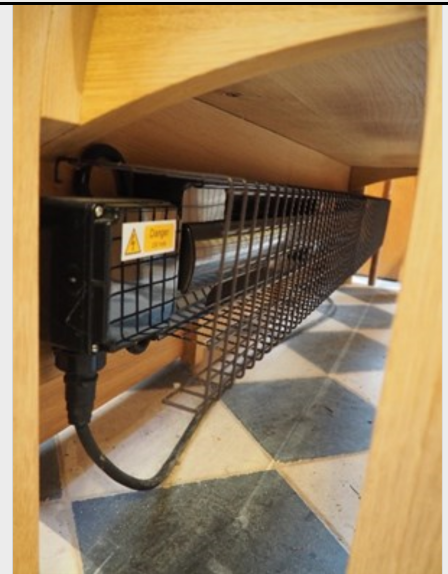
3 New choir stalls in the chancel house electric pew heaters that warm the user from below. The heaters are turned on for half an hour during the service, to keep the choir comfortable.

The chancel heating is very successful: the under-pew heaters keep the choir comfortable without attempting to warm the whole space. This also limits excessive heating and cooling of the medieval wall paintings. The heaters run for 30 minutes during the service and have an automatic cut-off.
