# CASE STUDY A LARGE, LISTED CHURCH IS HEATED EFFICIENTLY BY AN AIR SOURCE HEAT PUMP

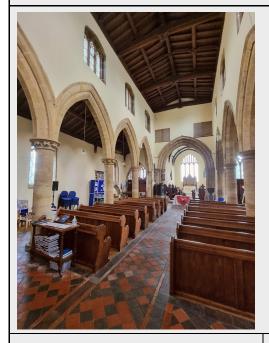
St Egelwin's spacious nave is heated by four large but unobtrusive blower units attached to the ceiling in the north and south aisles. In the chancel, the heating is supplemented by four electric wall heaters. There are electric underpew heaters too, but these are rarely used. 2 One of the blower units in the north aisle, as well as cabling for it running down the wall.

- Two air source heat pumps were installed.
- Four large blowing units were fixed inside St Egelwin's: two in the north aisle and two in the south aisle. They direct air towards the central aisle of the nave. Despite their size, the blowers are placed and coloured in such a way that makes them an unobtrusive presence.
- The system provides 50kW heat for the church, directed towards the congregation.

The blowers are quiet when in operation, but provide an effective source of heating for the church. They are typically turned on 3-4 hours prior to an event, when in use.
